Manhole Inspection Summary

Manhole # S07EE1012MH

Insp Date: **7/6/07 9:22 AM**

Location Address: **4101 CALLAWAY AVE**

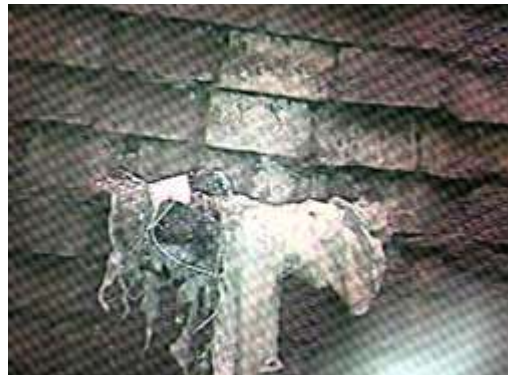
Defect 1

☒ **Evidence Of Surcharge** Depth: **5** (ft.) ☐ Active Surcharge Present

evidence of surcharge and corroded step

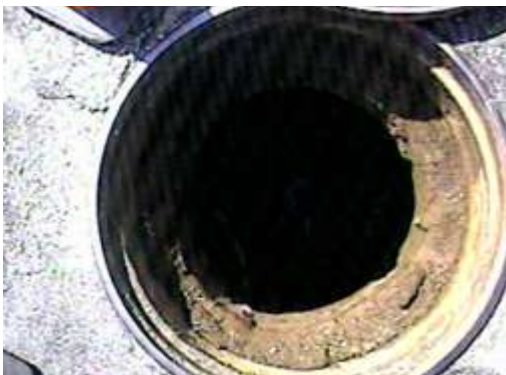
Defect 2

Offset frame

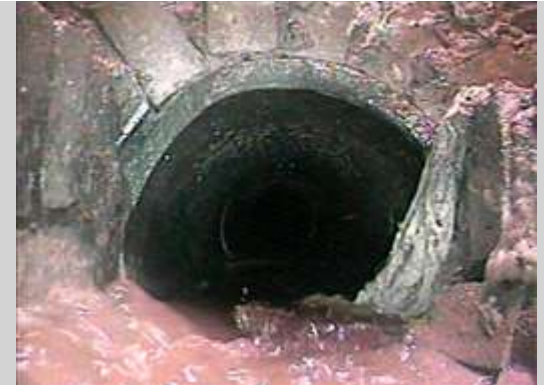
12 O'Clock Outflow

Pipe Height: (in.) Direct
Pipe Material: **Clay** ☐ Pipe Lined
Invert Depth: **10.26** (ft.) Flow Characteristics: **Fast**
Deposits: ☒ None ☐ Mud ☐ Sludge ☐ Debris ☐ Grease
Silt Depth: (in.) Deposits Extent:
Infiltration: **None** Pipe Seal Cond: **Sound**

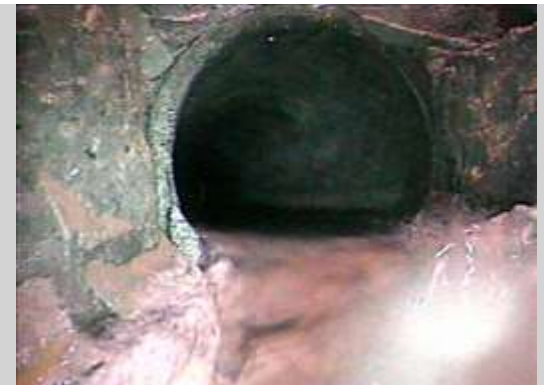
3 O'Clock Inflow

Pipe Height: (in.) Direct
Pipe Material: **Clay** ☐ Pipe Lined
Invert Depth: **10.02** (ft.) Flow Characteristics: **Fast**
Deposits: ☒ None ☐ Mud ☐ Sludge ☐ Debris ☐ Grease
Silt Depth: (in.) Deposits Extent:
Infiltration: **None** Pipe Seal Cond: **Sound**

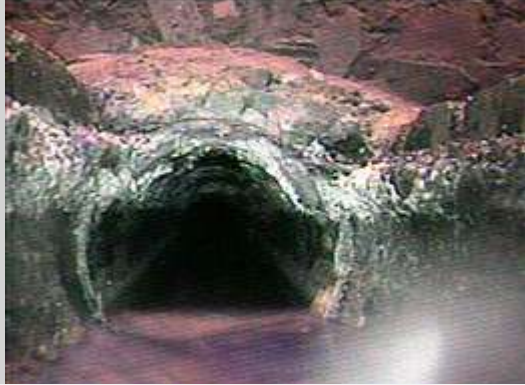
6 O'Clock Inflow

Pipe Material: **PVC** ☐ Pipe Lined

Invert Depth: **10.30** (ft.) Flow Characteristics: **Fast**

Infiltration: **None** Pipe Seal Cond: **Sound**
